May 5, 2014

**SUBJECT: REMEDIAL MEASURES FOR METRO GOLDLINE BRIDGE
STRUCTURES - 101 BRIDGE AND CHINATOWN STATION AERIAL
GUIDEWAY (C1092)**

This report is to update the Metro Board of Directors on the status of the repairs needed for the Gold Line 101 Bridge and Chinatown aerial structure. Observations made recently by Metro Facilities Maintenance and inspection made by Metro Engineering concluded that the structures were safe but repairs were needed. Because there were no load bearing structural damages observed to the bridges, it was safe to continue operations without any interruption. However, to protect the public from potential falling of concrete spalls, a repair is required. CEO Art Leahy authorized the use of "Remedial Measures for Metro Gold Line Bridge Structures" to allow a streamlined procurement of the required repairs.

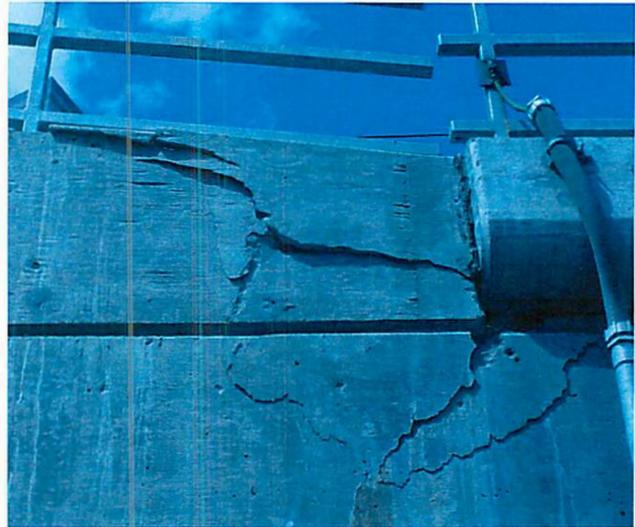
On April 11, Metro Engineering and Facilities Maintenance visited the site of the reported spalling concrete at the 101 bridge. As seen in the photo to the right, the concrete curb on the abutment was being crushed by the curb on the bridge which was pushing on the abutment. The movement exceeded the width of the as constructed gap at the movement joint. Once the bridge closed the joint gap, further movement caused distress between the curb on the abutment and the curb on the bridge causing the additional strain. It is believed that a wider gap between the abutment and the bridge curbs would eliminate the problem, and a design has been developed to provide for this wider gap.

During the field visit it was also observed that the joint seal at the abutment was not properly installed, causing water leakage, which in turn caused surface corrosion of the abutment rebar. The design for the repair work will provide for the removal and replacement of the joint seal.

During the last two weeks Metro Engineering has developed the design for the repairs of the structures and a solicitation for a Design Bid Build Contract (C1092) was prepared to remediate the spalling and cracking observed at both the 101 Bridge site and at the Chinatown Station site.

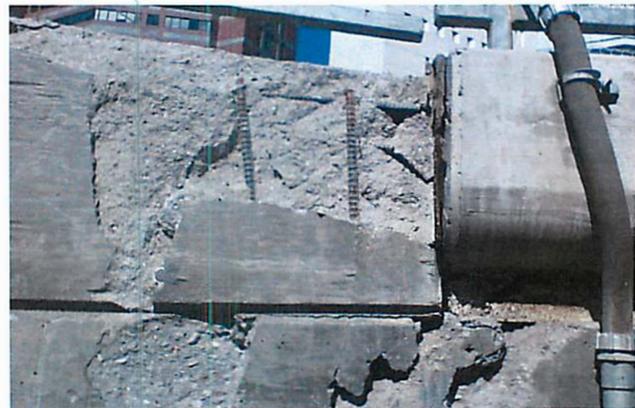
The first step was to ensure public safety. Loose and spalling concrete was removed mechanically to eliminate any potential hazard due to falling concrete for any persons below the damaged area. As seen in the photo to the right the loose concrete plates have been removed eliminating the hazard. However, the reinforcement is now exposed and requires remediation before further corrosion proceeds.

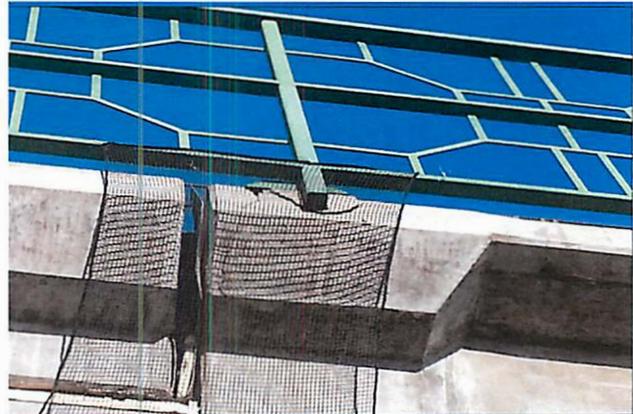
At the Chinatown station, spalling has again occurred but for a different reason. The area of distress occurs at the anchorage support of a guardrail fence along the edge of the elevated guideway. The damage is occurring adjacent to a movement joint. The long sections of concrete guideway girders are interrupted and joints are provided to allow movement between these long segments. The guardrail fence that is supported on the guideway is also provided with slip joints (sleeves in the guardrail) to

accommodate that movement. However, in this instance, the guardrail joints and the movement joints were not coordinated and do not occur at the same location as intended. The result is that when the Guideway Bridge moves, the stress is transferred to the guardrail. The guardrail responds by trying to resist the movement of the guideway and surface damage to the concrete has occurred. The weakest part of the guardrail is its connection at the post base. There the anchors are again causing spalling and local cracking to the concrete.

As seen in the photo to the right, spalling at the post base is caused by the guardrail trying (and failing) to resist the movement of the guideway bridge across the movement joint.
