Los Angeles County
Metropolitan
Transportation
Authority

SUBJECT: MTA CONSTRUCTION NONCONFORMANCE REPORTS

Attached please find copies of the Nonconformance Reports (NCRs) received by the MTA Director of Quality Management for the period of January 19-25, 1996.

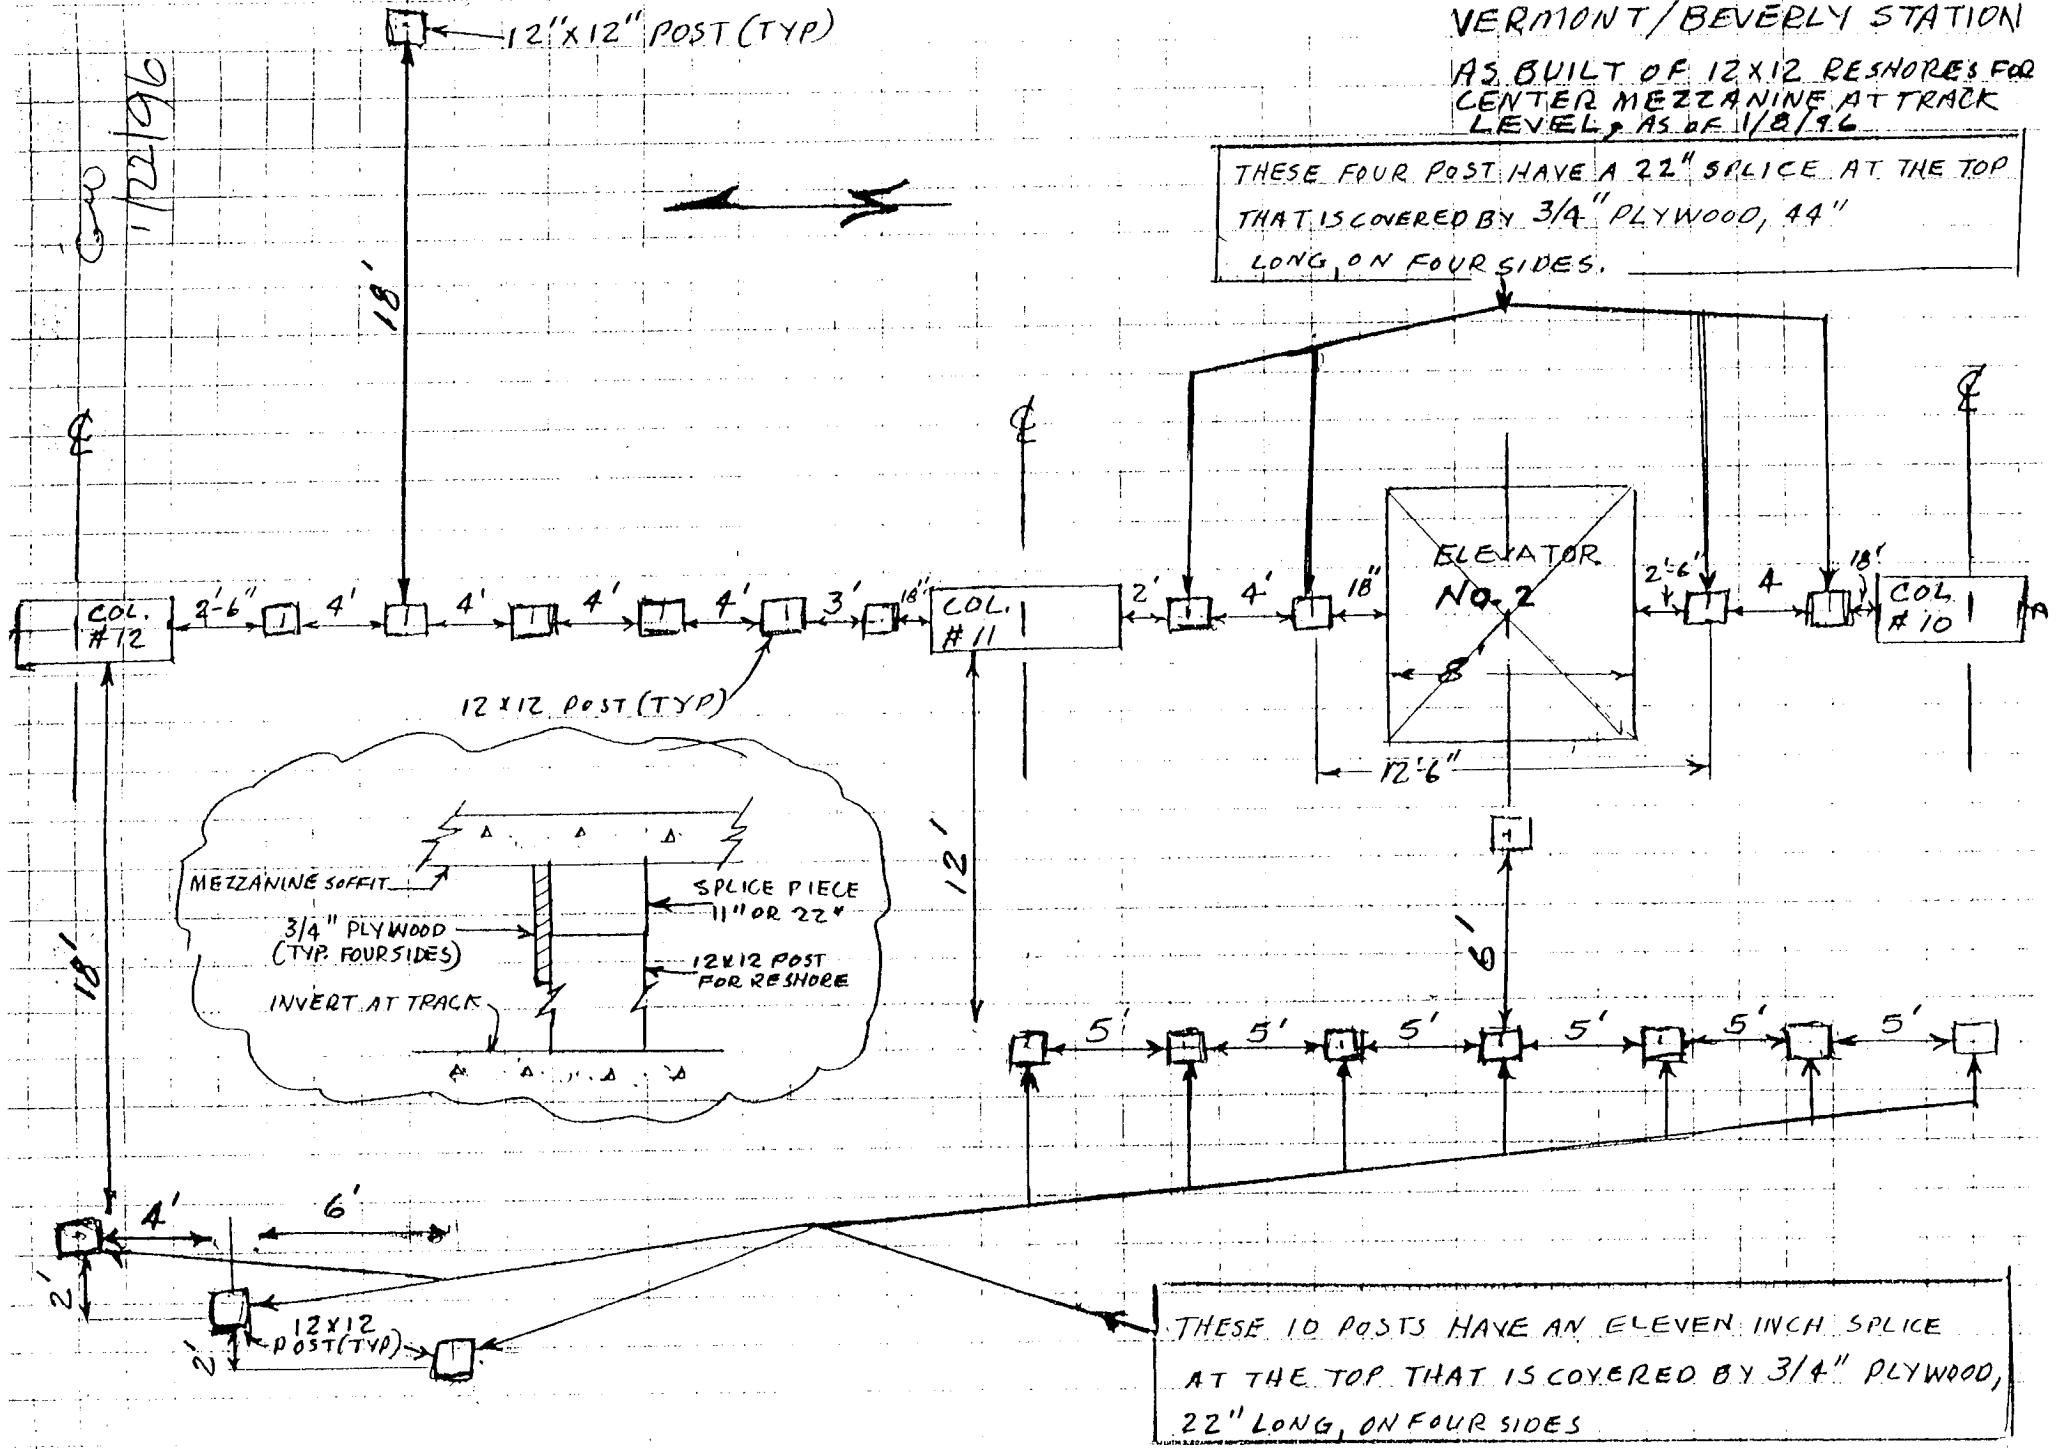
CONTRACT NO. 241
 VERMONT/BEVERLY STATION
 AS BUILT OF 12X12 RESHORES FOR
 CENTER MEZZANINE AT TRACK
 LEVEL, AS OF 1/8/96

9. Contract requirement : Substitutions in methods of construction shall be submitted in accordance with the provisions of specification section 01300. This shall include detailed description of proposed methods and working drawings illustrating the methods. Non-conformance Description: The contractor has spliced several reshore timbers under the center mezzanine level. The splicing details were not submitted on the original submittal and, to date, have not been submitted for approval. See attached sketch for locations.

THESE FOUR POST HAVE A 22" SPLICE AT THE TOP
 THAT IS COVERED BY 3/4" PLYWOOD, 44"
 LONG, ON FOUR SIDES.

THESE 10 POSTS HAVE AN ELEVEN INCH SPLICE
 AT THE TOP THAT IS COVERED BY 3/4" PLYWOOD,
 22" LONG, ON FOUR SIDES
