Los Angeles County
Metropolitan
Transportation
Authority

SUBJECT: MTA CONSTRUCTION NONCONFORMANCE REPORTS

Attached please find copies of the Nonconformance Reports (NCRs) received by the MTA Director of Quality Management for the week of September 1 - 14, 1995.

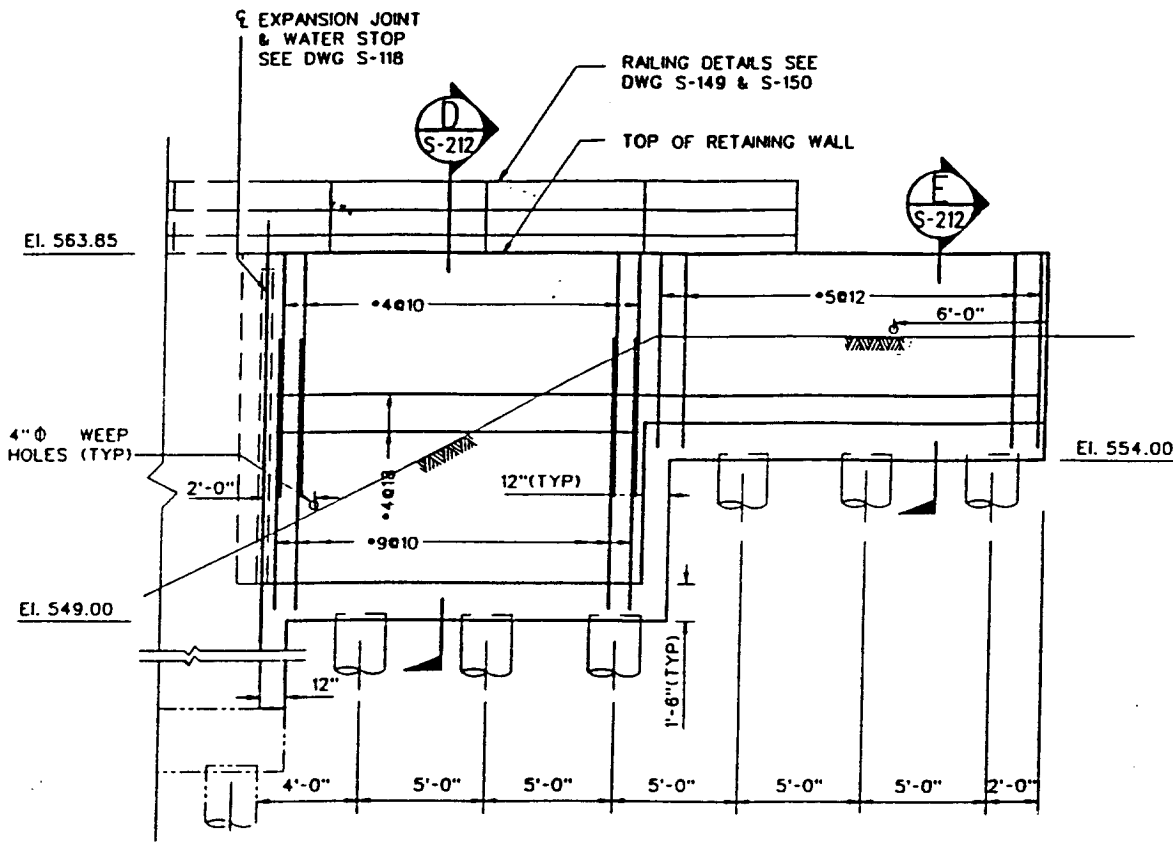
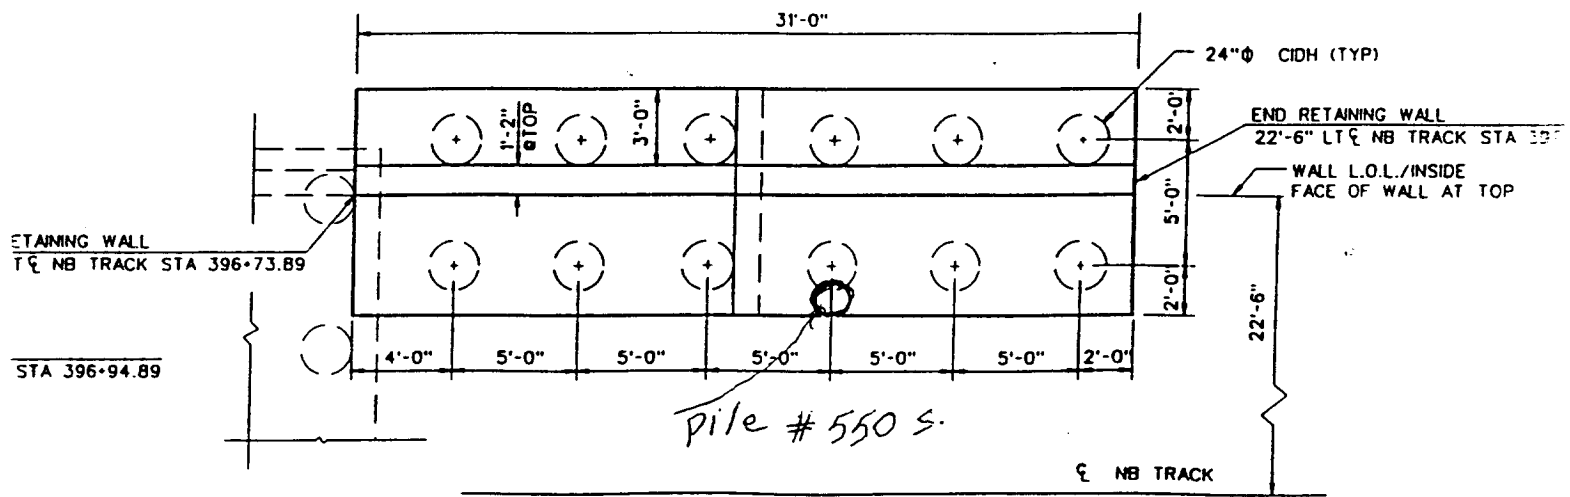
ELEVATION - ABUT 12 INTERFACE RETAINING WALL (NORTH)

7. Specification/Drawing No.: <i>2387-1.2E, plan sheet # 130</i>			8. Originator: Phone Number: <i>Mohammad Alazzah (213) 258 7284</i>		
9. Nonconformance description and contract requirements: <i>The 24" CIDH pile # 550 S. constructed under abut. 12 interface wall (North) had been shifted toward the edge of the footing by 10" to 12" from it's corrected location according to plan sheet # 130 (see the attached sheet # 2 of 2)</i>

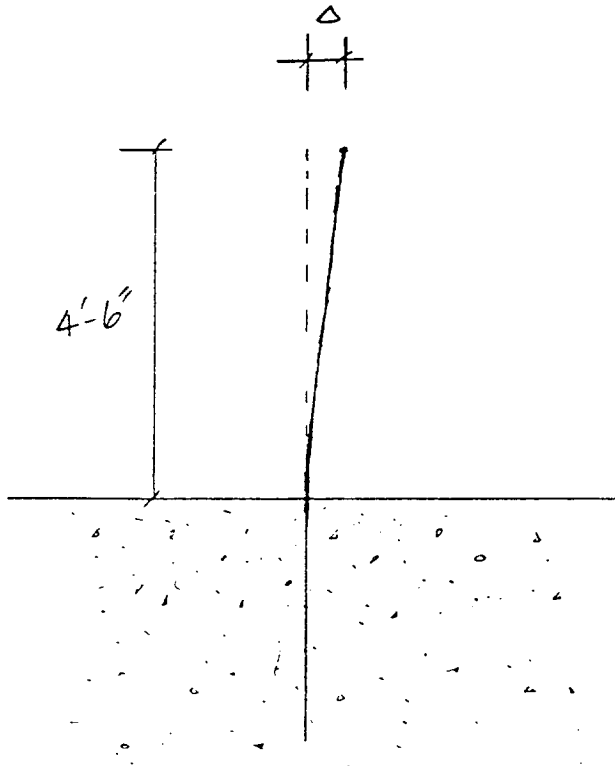
7. Specification Section/Drawing No.:		8. Originator:		Phone No.:	
ACI 318		J. A. Vandrey		913-0095	
				Hold Tag No. N/A	
9. Contract requirement and nonconformance description:					
ACI 318 PARAGRAPH 7.3.2 - REBAR PARTIALLY EMBEDDED IN CONCRETE SHALL NOT BE BENT. FOURTEEN (14) #9 REBARS FOR THE INNER FACE OF THE EXTERIOR WALL, BETWEEN GRID LINES 1 & 6.5, ARE BENT 4" TO 31" OUT OF PLUMB. EXPOSED LENGTH IS 4'-6".

10. Lead Inspector:		Date:		11. Reply requested from:	
Gary Rudy		8/4/95		SHERMAN LEE	
				12. Reply due date:	
				8/11/95	
13. Root cause of the problem and action(s) to prevent recurrence (completed by the contractor):					
DURING THE STRUT REMOVAL & FORMING OPERATION, OUR FIELD PERSONNEL ACCIDENTALLY BENT THE REBARS AS INDICATED ON ATTACHED SHEET 1/3. WE HAVE MODIFIED OUR OPERATION PROCEDURE WHICH WILL PREVENT THE PROBLEM FROM HAPPENING.

LOCATION	Δ (IN.)	NO. OF BARS BEAT
# 1	4"	1
# 2	4"	1
# 3	4"	2
# 4	4"	1
# 5	4"	1
# 6	4"	2
# 7	4"	1
# 8	4"	1
# 10	4"	1
# 11	5"	2
# 12	5"	1
# 13	8"	1
# 14	31"	1

20. Lead Inspector: Date:					
Gary Rudy 8/25/95					
21. Verification that nonconforming condition has been corrected:					
EXISTING CONCRETE AROUND THE BENT BARS INSPECTED & FOUND TO BE ACCEPTABLE. BENT BARS STRAIGHTENED PER RECOMMENDED PROCEDURE - CONCRETE WAS THEN REINSPECTED & FOUND ACCEPTABLE - BARS ARE NOW ACCEPTABLE - (SEE PG. #3)

BY CONSIDERING THE LOADING & STRUCTURAL BEHAVIOR OF THE EXTERIOR WALL, THE INTERIOR FACE AT THE TOP OF INVERT SLAB WILL GENERALLY BE SUBJECTED TO COMPRESSION FORCE WHICH USUALLY MEANS THE REBAR IS NOT A CRITICAL STRUCTURE COMPONENT. PER ATTACHED ACI CODE, WE PROPOSE TO PROCEED WITH ONE OF THE FOLLOWING CORRECTIVE ACTIONS:

1. STRENGTHENING THE REBAR, THEN CONTINUING WITH VERTICAL REBAR SPLICE.
2. LEAVE BENT REBARS AS-IS AND PROCEED WITH OFFSET SPLICE.

Recommended correction procedure for the bent rebars (Dowels):

1. Thoroughly inspect the existing concrete surface around the bent bars. If there is concrete crack or breakage, repair the defects to meet spec. requirements (Method such as epoxy pressure grout the concrete).
2. Straightening-up the rebars with bent off-set more than 5 inches from their original position. Proper method has to be used for straightening the rebar without damaging the concrete and rebar.
3. Process of straightening-up the bent bars should be gradual and follow all requirements of ACI-318-89 section 7.3.

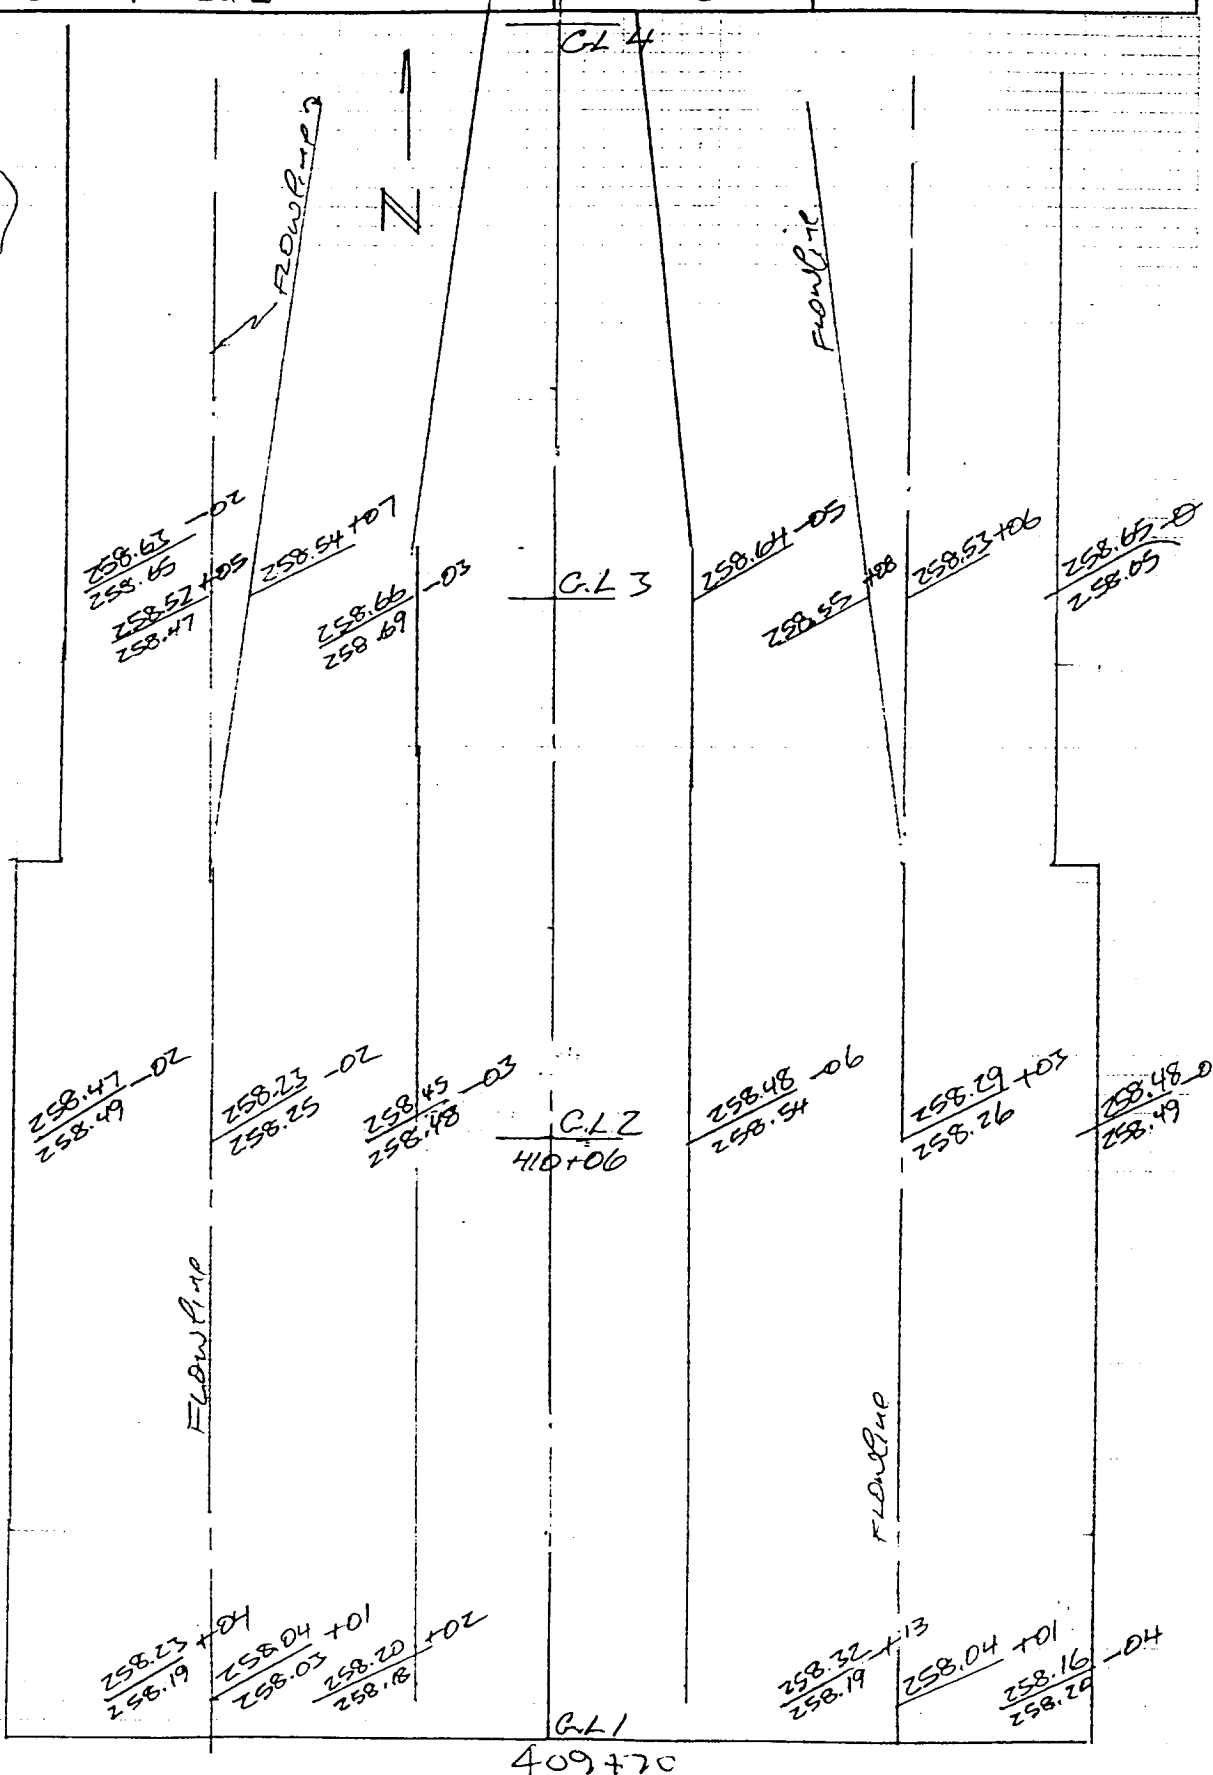
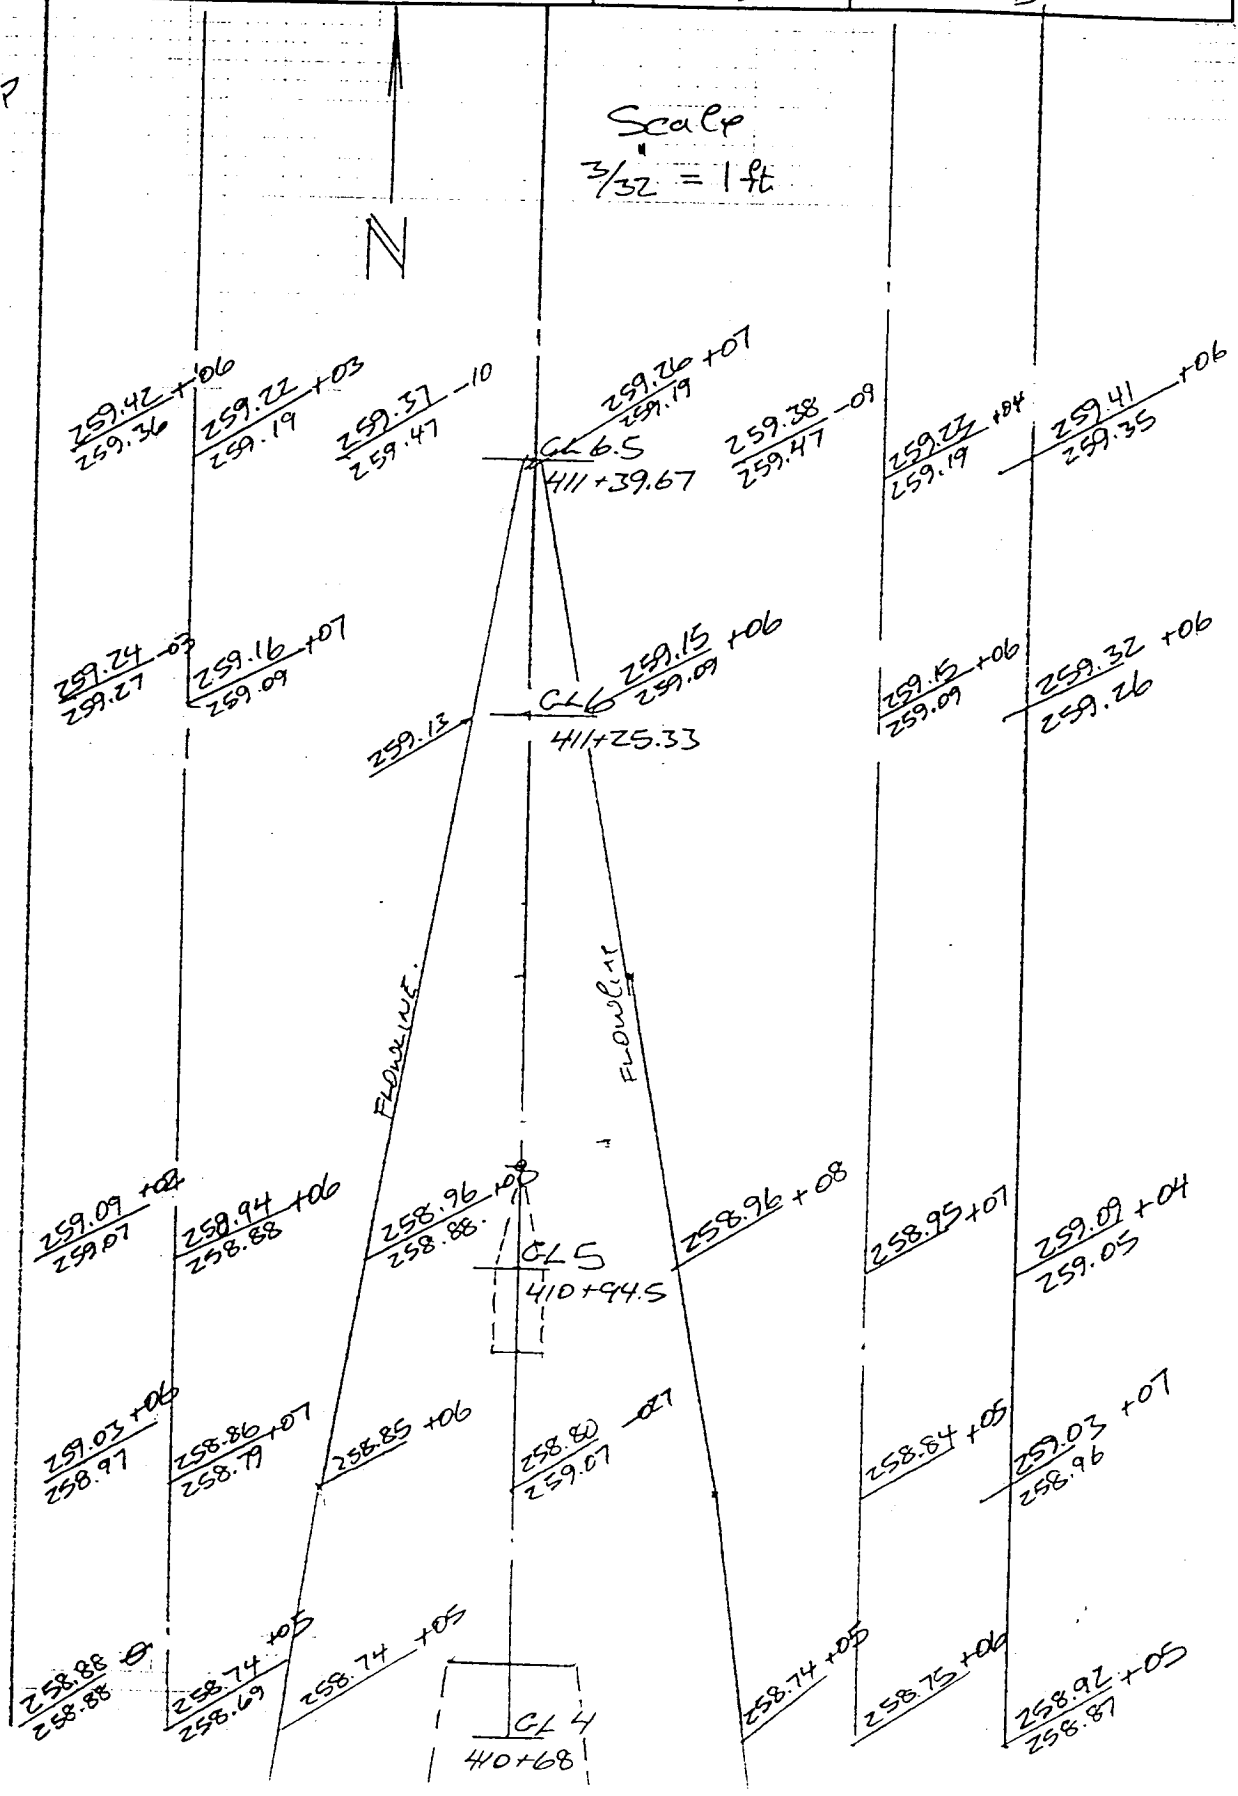
9. Contract requirement and nonconformance description: <i>SPECIFICATION 03300, REQUIRES ELEVATION OF THE INVERT SLAB BE ± 1/4" FROM DESIGN. "AS BUILT" SURVEY OF THE FINISHED SLAB, FROM 409+70 TO 411+39.67 INDICATES THAT THE ELEVATION VARIES FROM + 1 1/2" TO - 1/4" FROM THE DESIGN ELEVATION. (SEE ATTACHMENT #1 & 2)</i>
